1.3L ENG NO START/BLOWN FUSE - SHORT IN WIRE HARNESS CAT. 15, NO. 012/85

1983 Mazda RX7

TECHNICAL SERVICE BULLETIN

"ENGINE" Fuse Blows/No Start

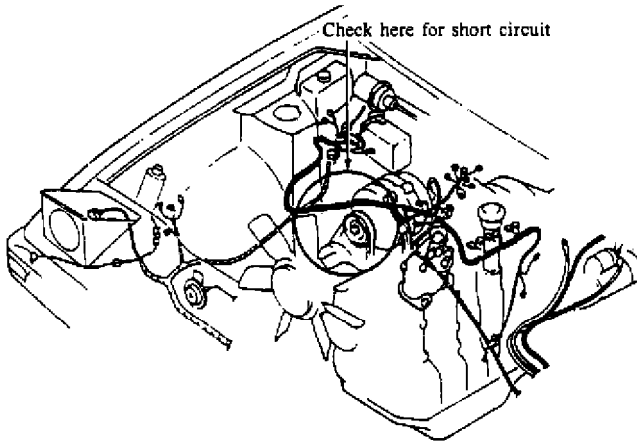
Fig. 1: View of Wiring Harness

Some 1979-84 RX7 vehicles may exhibit an "ENGINE" fuse that blows, preventing the engine from starting. This problem may be caused by an electrical short circuit in the wiring harness.

Check for a short circuit in the wire harness in the area of the thermostat and air hose to the air cleaner. See Fig. 1.

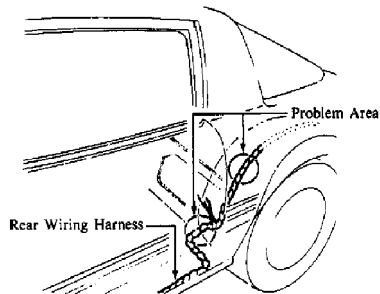
Fig. 1: View of Rear Wiring Harness

- * RADIO, ANTENNA fuse blown
- * TAIL, ILLUM fuse blown
- * METER, BACK fuse blown
- * OPENER fuse blown
- * Inoperative rear defroster/rear wiper
- * Rear wiper operates with wiper switch in OFF position

One or more of the above problems may be caused by a short circuit in the rear harness. The rear harness may be cut by a sharp metal edge where the harness is routed over the inner wheel well. See Fig. 1. This was fixed in production beginning with VIN JM1FB33 F0852204.

If this problem is present, repair the rear harness as necessary.

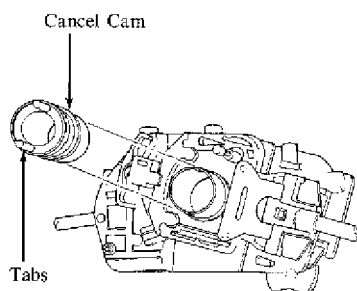
Fig. 2: Turn Signal Cancel Cam

If the turn signal switch does not cancel, the most probable cause is a broken cancel cam. The cancel cam is available separately and can be replaced as shown below.

3. Inspect the cancel cam. If the tabs are broken off the cancel cam, the combination switch can be repaired by replacing the cancel cam. See Fig. 2.

4. Place the turn signal in the "OFF" position .
5. Carefully pry the cancel cam from the combination switch using a screwdriver. See Fig. 3.
6. Install the new cancel cam to the combination switch.

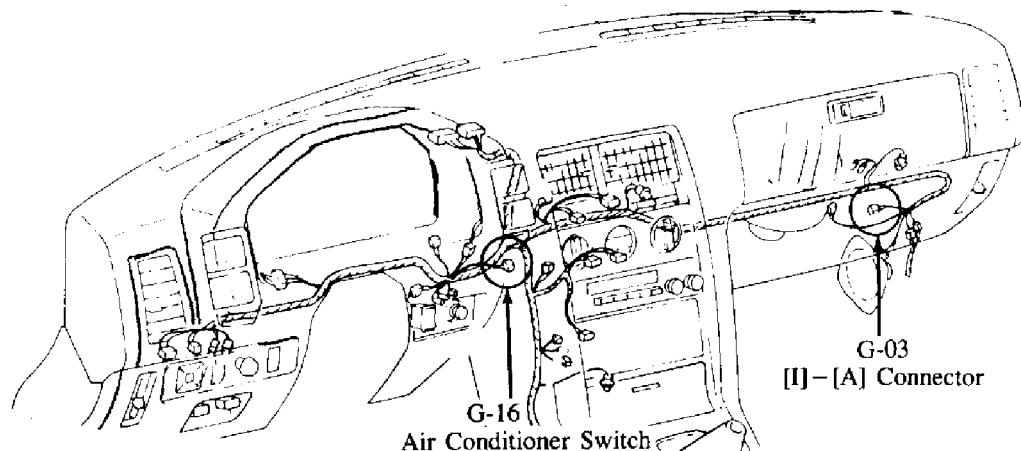
Fig. 1: A/C Indicator Light Harness Routing

Some air conditioner kits manufactured by Lone Star Manufacturing Company may contain incorrectly assembled harness connectors. If the indicator light on the air conditioner switch does not illuminate, or illuminates dimly after installation, the problem may be due to incorrectly assembled G-03 or G-16 connectors. See Fig. 1.

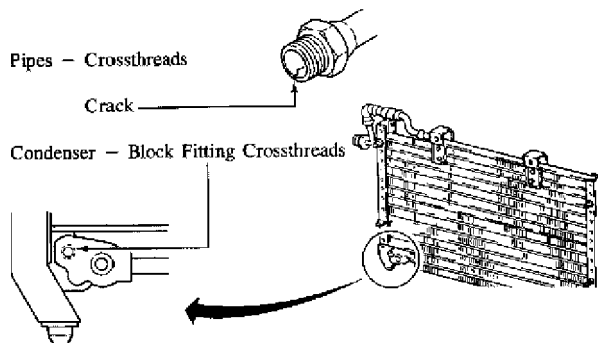
Fig. 3: Damaged Component Illustration

Most of the leaks from the pipe connection can be fixed with O-ring replacement and proper torquing, but please pay attention to the failure on pipe and components. (Fig. 3)

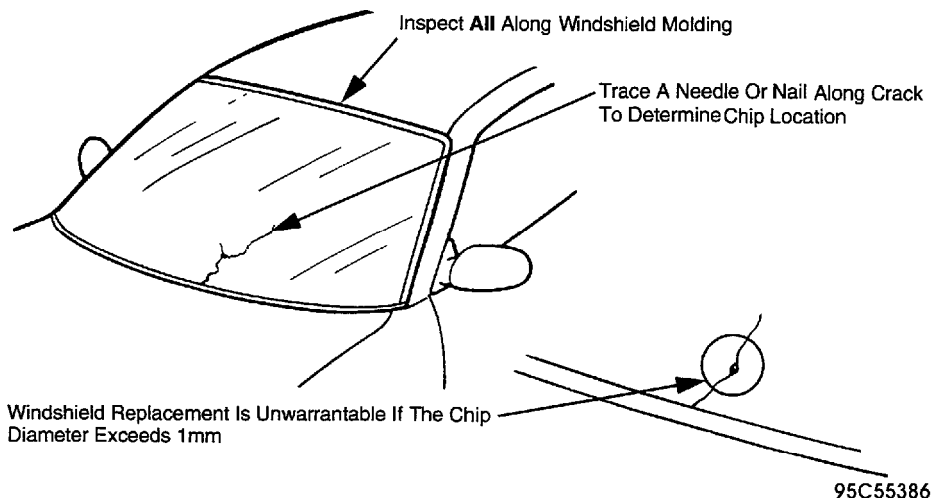
Fig. 1: Windshield Inspection

Windshield replacement is not warrantable if a chip larger than 1 mm in diameter exists along the length of the crack.
