1.3L ENG NO START/BLOWN FUSE - SHORT IN WIRE HARNESS CAT. 15, NO. 012/85

1983 Mazda RX7

TECHNICAL SERVICE BULLETIN

"ENGINE" Fuse Blows/No Start

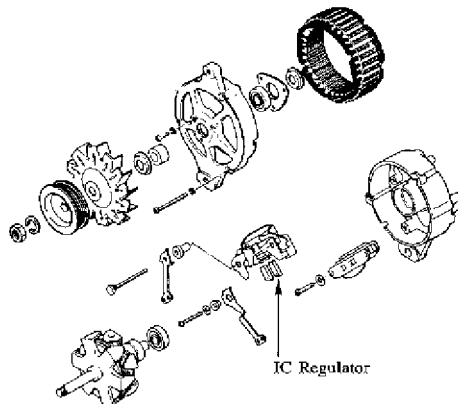
Fig. 1: Exploded View of Alternator

Checking procedure for the built-in IC regulator has been established to pin point the alternator problem. Basically, the alternator should be replaced as a unit through the exchange program. However, in case of a shortage of refurbished alternators, you may replace the IC regulator to minimize inconvenience of customers (see Fig. 1).

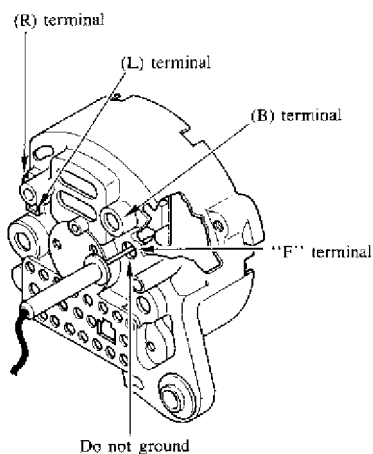
Fig. 2: Location of "F" Terminal

1. Make sure the battery is fully charged.
2. Turn ignition key on to "Ig" position. If the alternator warning light is "off", the problem is likely to be caused by regulator. Leave the key in "Ig" position and take the following step to assure the cause.
3. Insert volt meter between "F" terminal and nearest ground point (Fig. 2).
4. Do not ground to the body of the alternator while positive probe of voltmeter is inserted through the hole for "F" terminal.

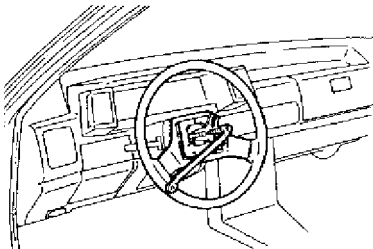
Fig. 1: Steering Wheel Removal

If the turn signal switch does not cancel, the most probable cause is a broken cancel cam. The cancel cam is available separately and can be replaced as shown below.

1. Put a mark on the steering wheel and steering shaft so that the steering wheel can be reinstalled in the same position.
2. Remove the retaining nut for the steering wheel and remove the steering wheel with a steering wheel puller. See Fig. 1.

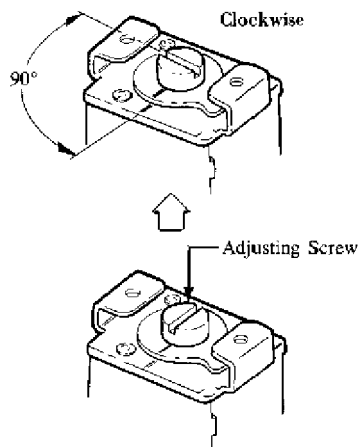
Fig. 3: Adjusting Thermostat

CAUTION: Do not turn the adjusting screw more than 90°, otherwise the evaporator core will freeze, resulting in an adverse effect on the cooling performance. See Fig. 3.

4. Turn the adjusting screw of the thermostat clockwise 90° from the original position.

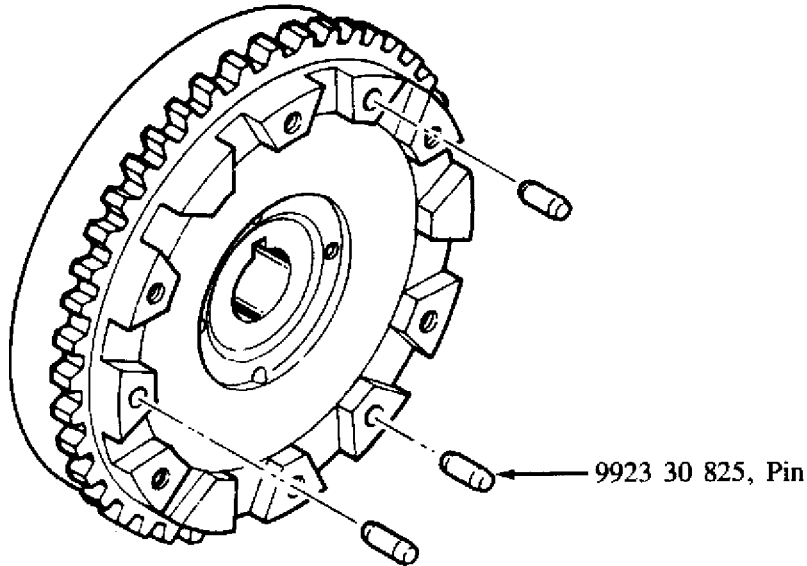
Fig. 1: 83-86 RX7 Flywheel and Alignment Pins

Replacement flywheels for the 1983-1986 RX-7 are shipped without clutch alignment pins. These pins are necessary to accurately align the clutch cover to the flywheel during assembly. Failure to use the alignment pins will result in vibration of the flywheel and clutch assembly. See Fig. 1.

When replacing the flywheel, please order the pin by the part number listed below.

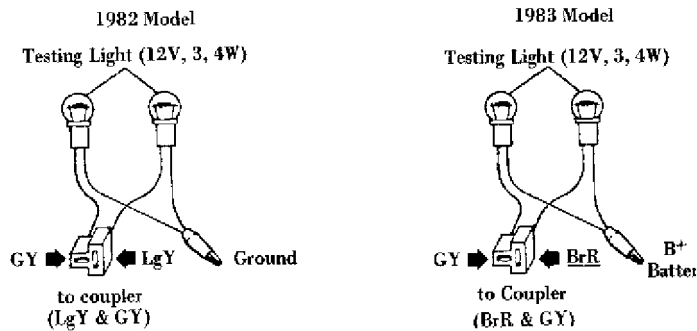
Fig. 1: View of Test Connections in 1982 & 1983 Models

In order to ease extensive damage on emission control unit and related components, electrical connection ("+" and "-") for the circuits has been reversed.

Due to a change in the vehicle's wiring, it is necessary to connect the alligator clip of the tester to B+ instead of ground when checking or adjusting the throttle sensor.

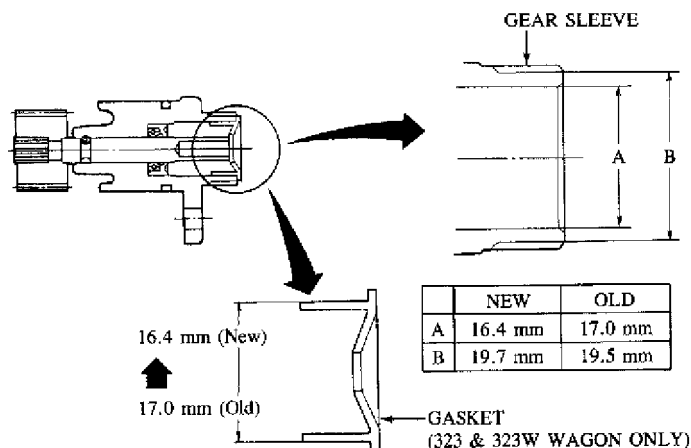
Fig. 1: Speedometer Gear Sleeve & Gasket Modifications

In order to improve the sealing ability of the joint between the speedometer cable and driven gear sleeve, the shape of the driven gear sleeve has been changed as shown. In addition, the shape of the gasket for the 323 has also been changed. These modifications were made on the production line since November 1, 1986.

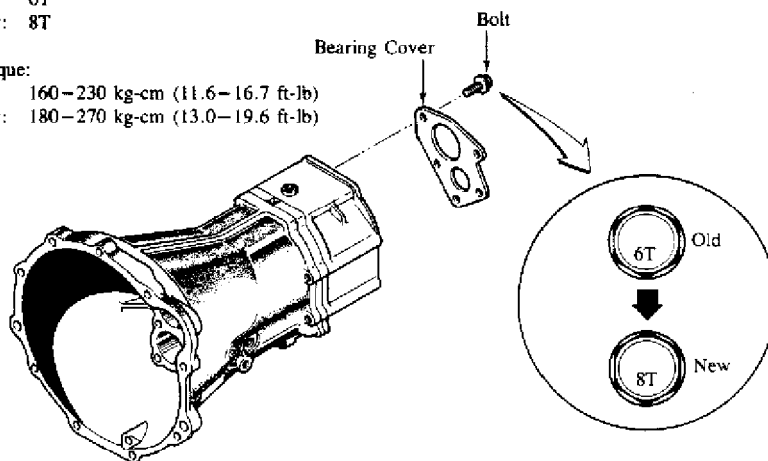
Fig. 1: Bearing Cover Bolt Modification

Old: 160-230 kg-cm (11.6-16.7 ft-lb)

New: 180-270 kg-cm (13.0-19.6 ft-lb)

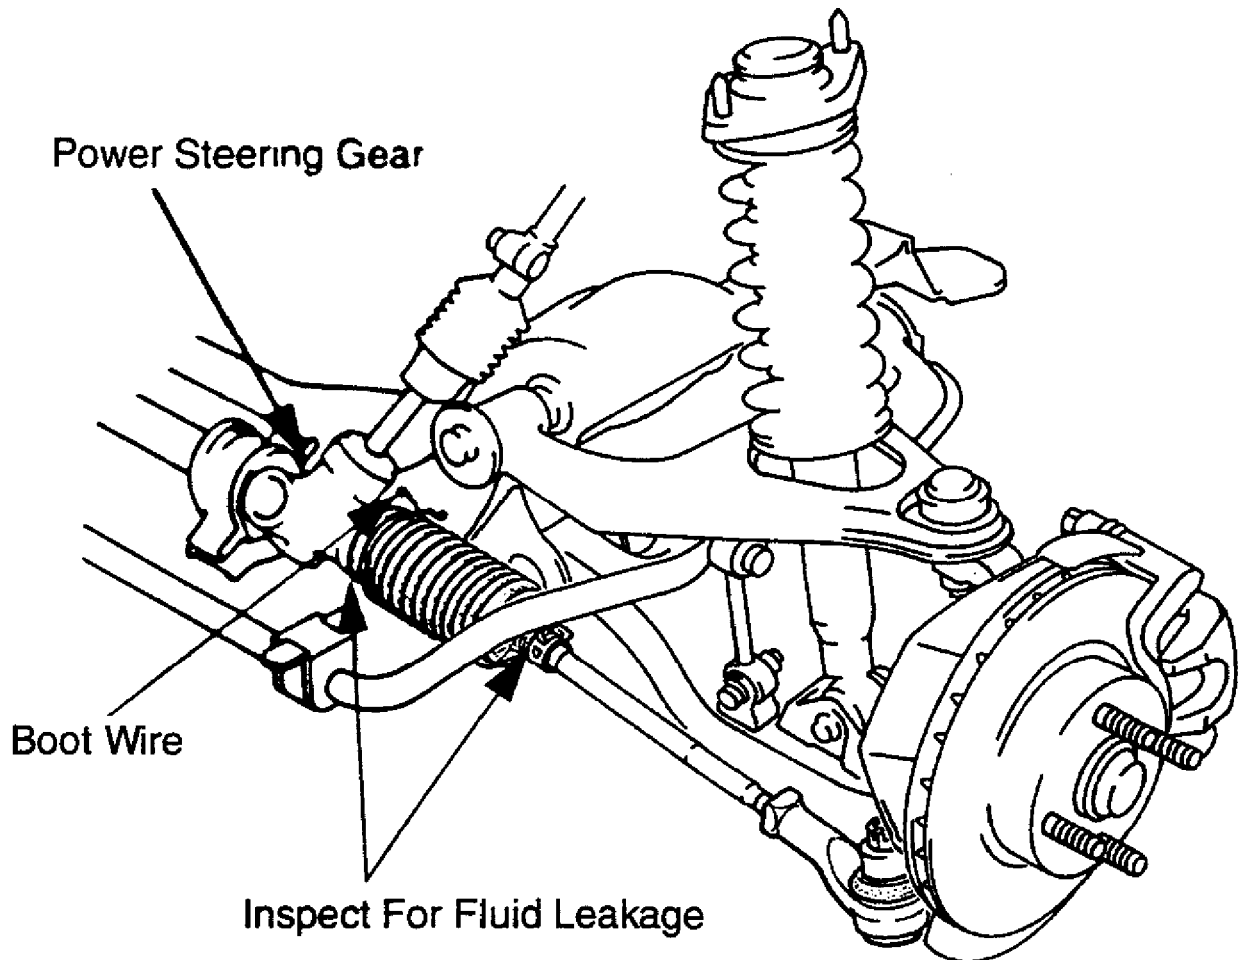
Fig. 1: Power Steering Gear & Boot Wire - Inspect Fluid Leakage

CAUTION: DO NOT keep the steering wheel fully turned to the locked position for more than five seconds. Power steering system damage may occur.

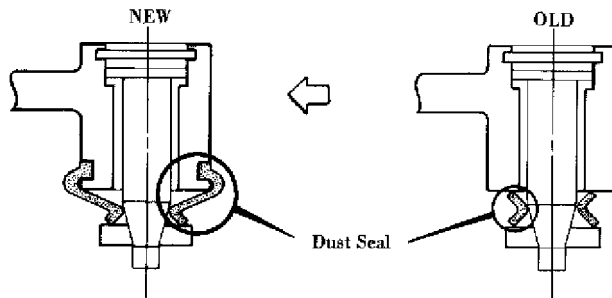
Fig. 1: Idler Arm Modification

To increase the sealing efficiency of the dust seal, the configurations of the dust seal and idler arm have been changed as shown since the production in March, 1983

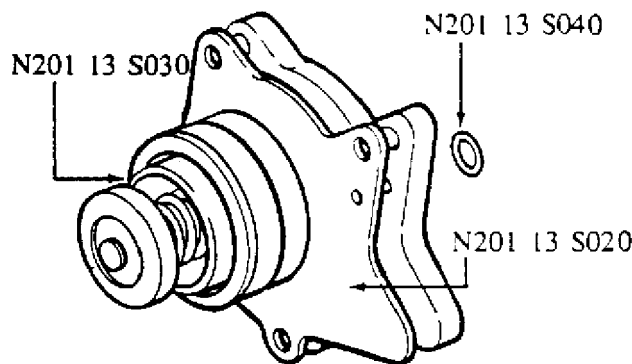
Fig. 1: Air Control Valve Components

- c. Gasket (P/N: N201 13 5020), Gasket (P/N: N201 13 5030) and "O" Ring (P/N: N201 13 5040) - These parts are the components of the air control valve, which may require being replaced in rare cases. See Fig. 1.
